New York State Department of Transportation

Yellow Flag NB2358W019

BIN: 1065318

Location: Span 164, Girder G14 bearing at Pier 164.

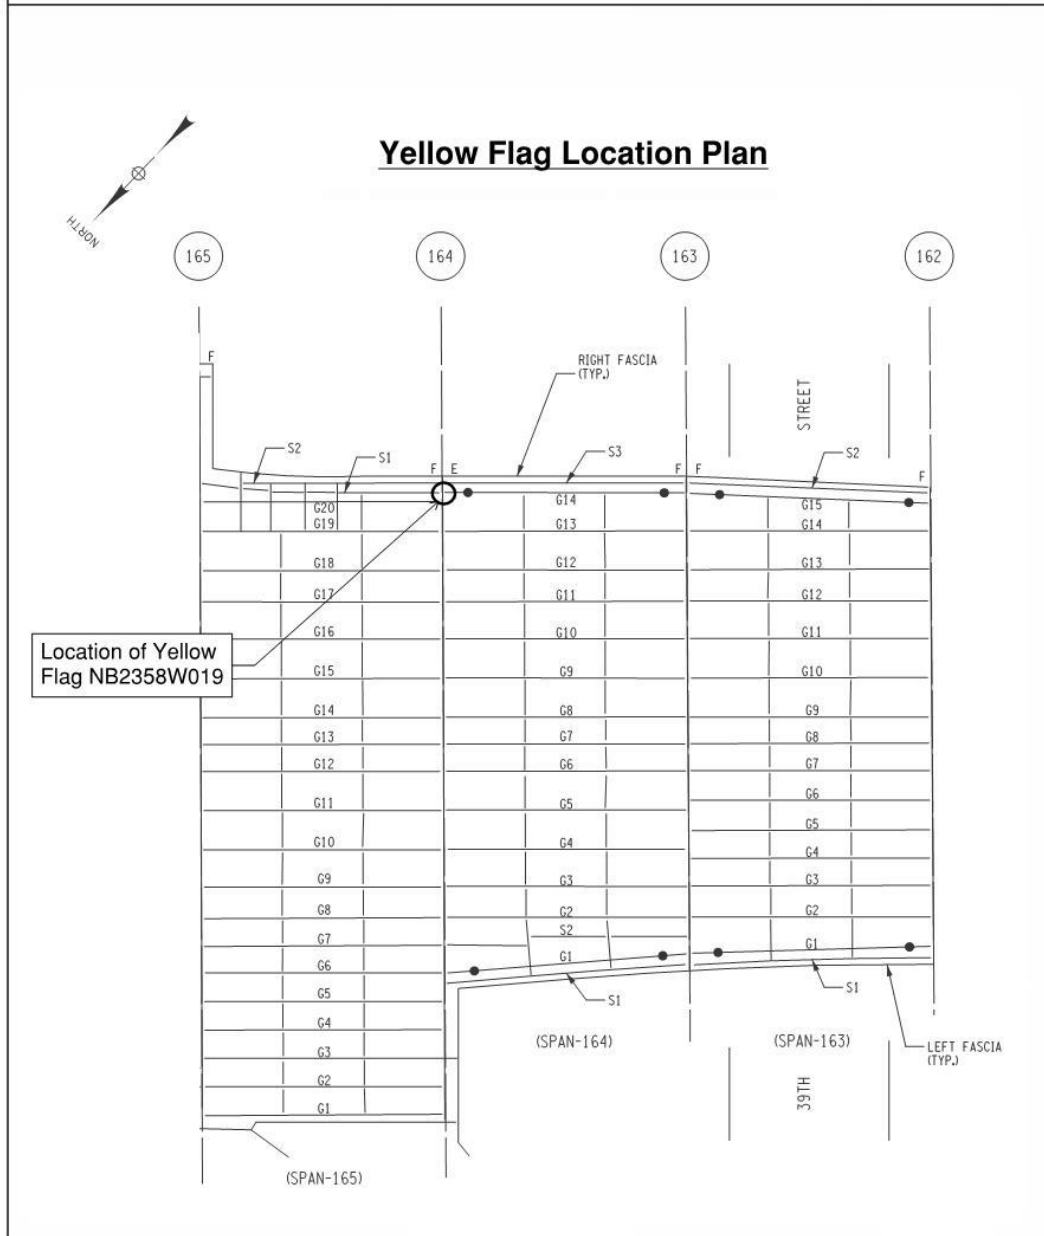
Flag PhotographsPhoto Number: **1**Photo Filename: **23_Flag Location Plan.jpg**Gowanus Expressway
2023 Biennial Inspection - Field SketchBIN: 1065318Team: AA/TSDate: 06/01/2023Span: 164Location: Bearing under G14 at Pier 164

**wsp****Attachment Description: Flag Location Plan**

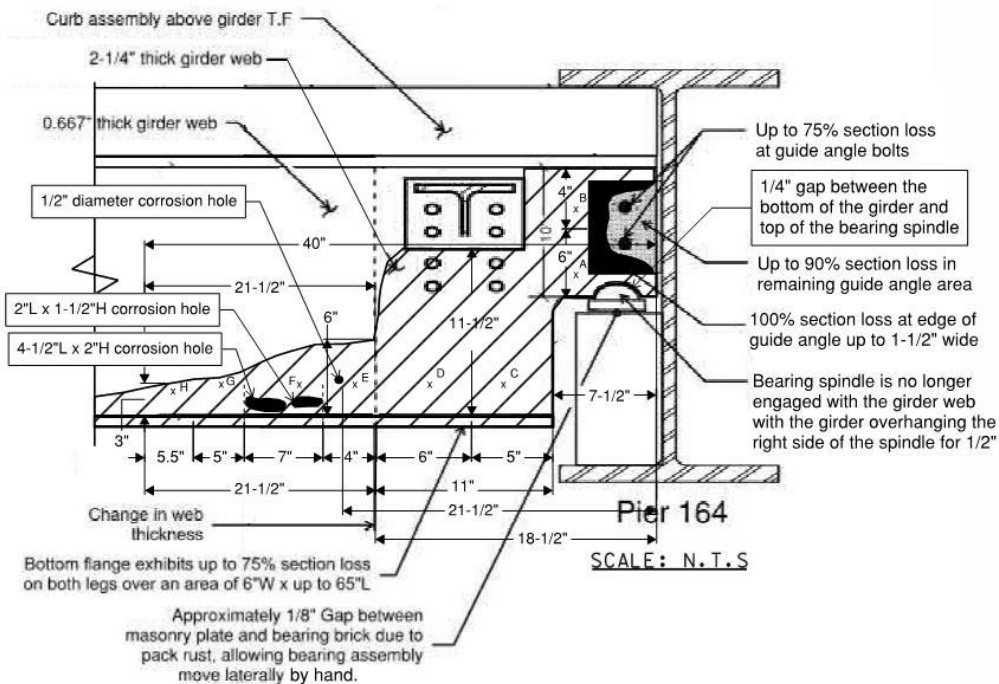
Photo Number: 2

(refer to Yellow Flag Condition Sketch Photo #2 for more details)

Right Face of Bearing under Girder G14

Point	D-Meter Readings (in)	Calculated Section Loss (%)
A	1.5	33%
B	2	11%
C	1.875	17%
D	1.82	19%
E	0.28	58%
F	0.125	81%
G	0.25	63%
H	0.3	55%

-As-measured web thickness is approximately 2-1/2" for approximately 18-1/2" long area starting at the girder end followed by 0.667" for remaining length of girder

$$6" \times 1.5" [\text{Point A}] + 4" \times 2.0" [\text{Point B}] = 17 \text{ in}^2$$

$$((10" \times 2.25") - 17 \text{ in}^2) / (10" \times 2.25") \times 100 = 24\%$$

$$5" \times 1.875" [\text{Point C}] + 6" \times 1.82" [\text{Point D}] + 3.5" \times 0.28" [\text{Point E}] + 0.5" \times 0" (1/2" \text{ diameter hole}) + 6.5" \times 0" (\text{two corrosion holes}) + 0.5" \times 0.125" [\text{Point F}] + 5" \times 0.25" [\text{Point G}] + 5.5" \times 0.30" [\text{Point H}] = 24.24 \text{ in}^2$$

$$((11" \times 2.25" + 21.5" \times 0.667") - 24.24 \text{ in}^2) / (11" \times 2.25" + 21.5" \times 0.667") \times 100 = 38\%$$

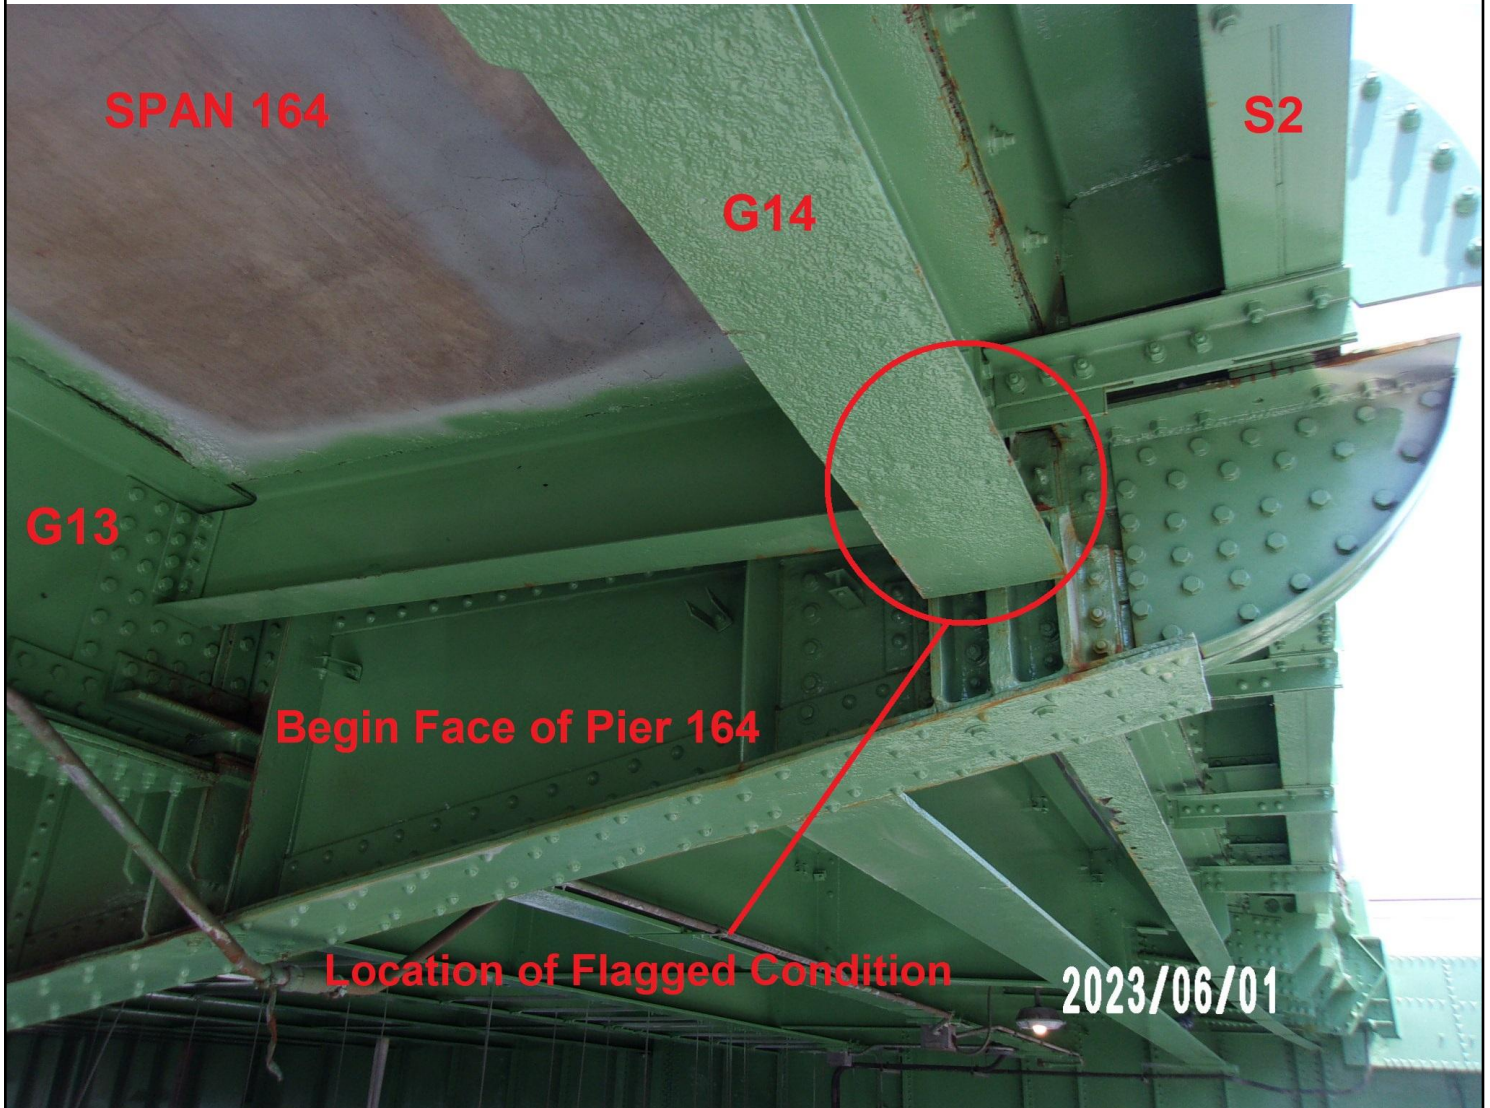
Photo Number: 3

Attachment Description: General view of the flagged condition at Girder G14 on Span 164 side of Pier 164. Looking End.

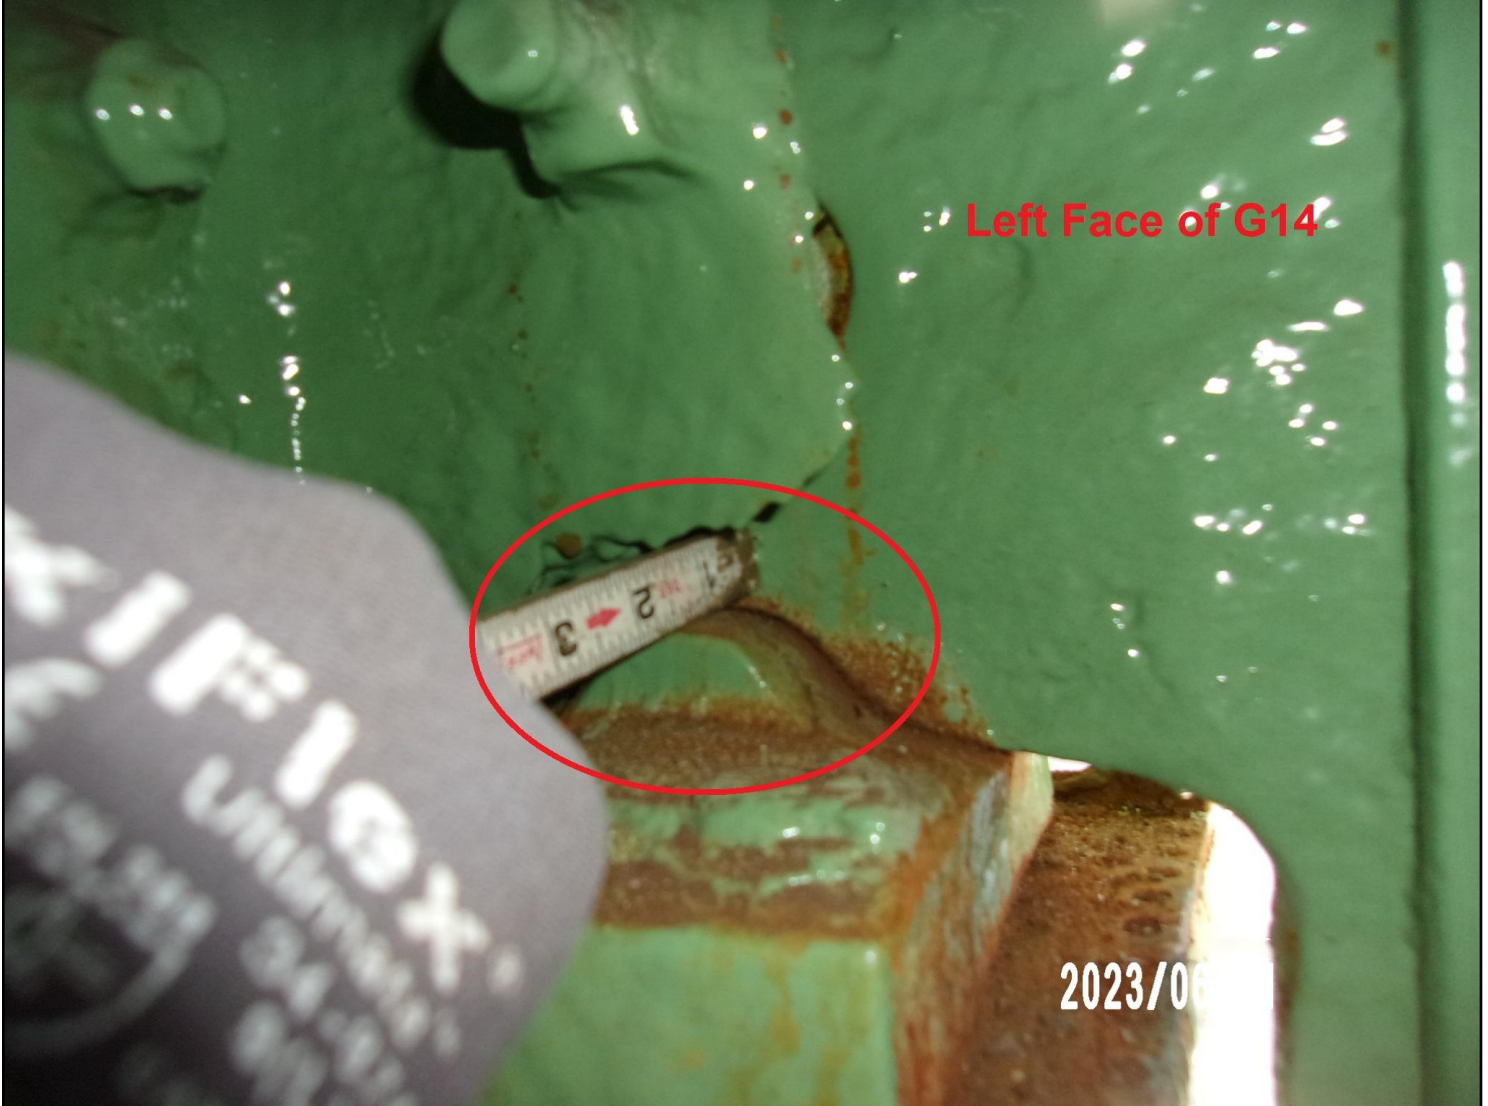
Photo Number: 4

Attachment Description: The left side of the bearing under Girder G14 on Span 164 side of Pier 164. The bearing is misaligned and no longer engaged with the girder with the bearing spindle pushed towards the left side with the left end of the bearing spindle approximately 1-1/2" from the face of the girder web. Looking Right.

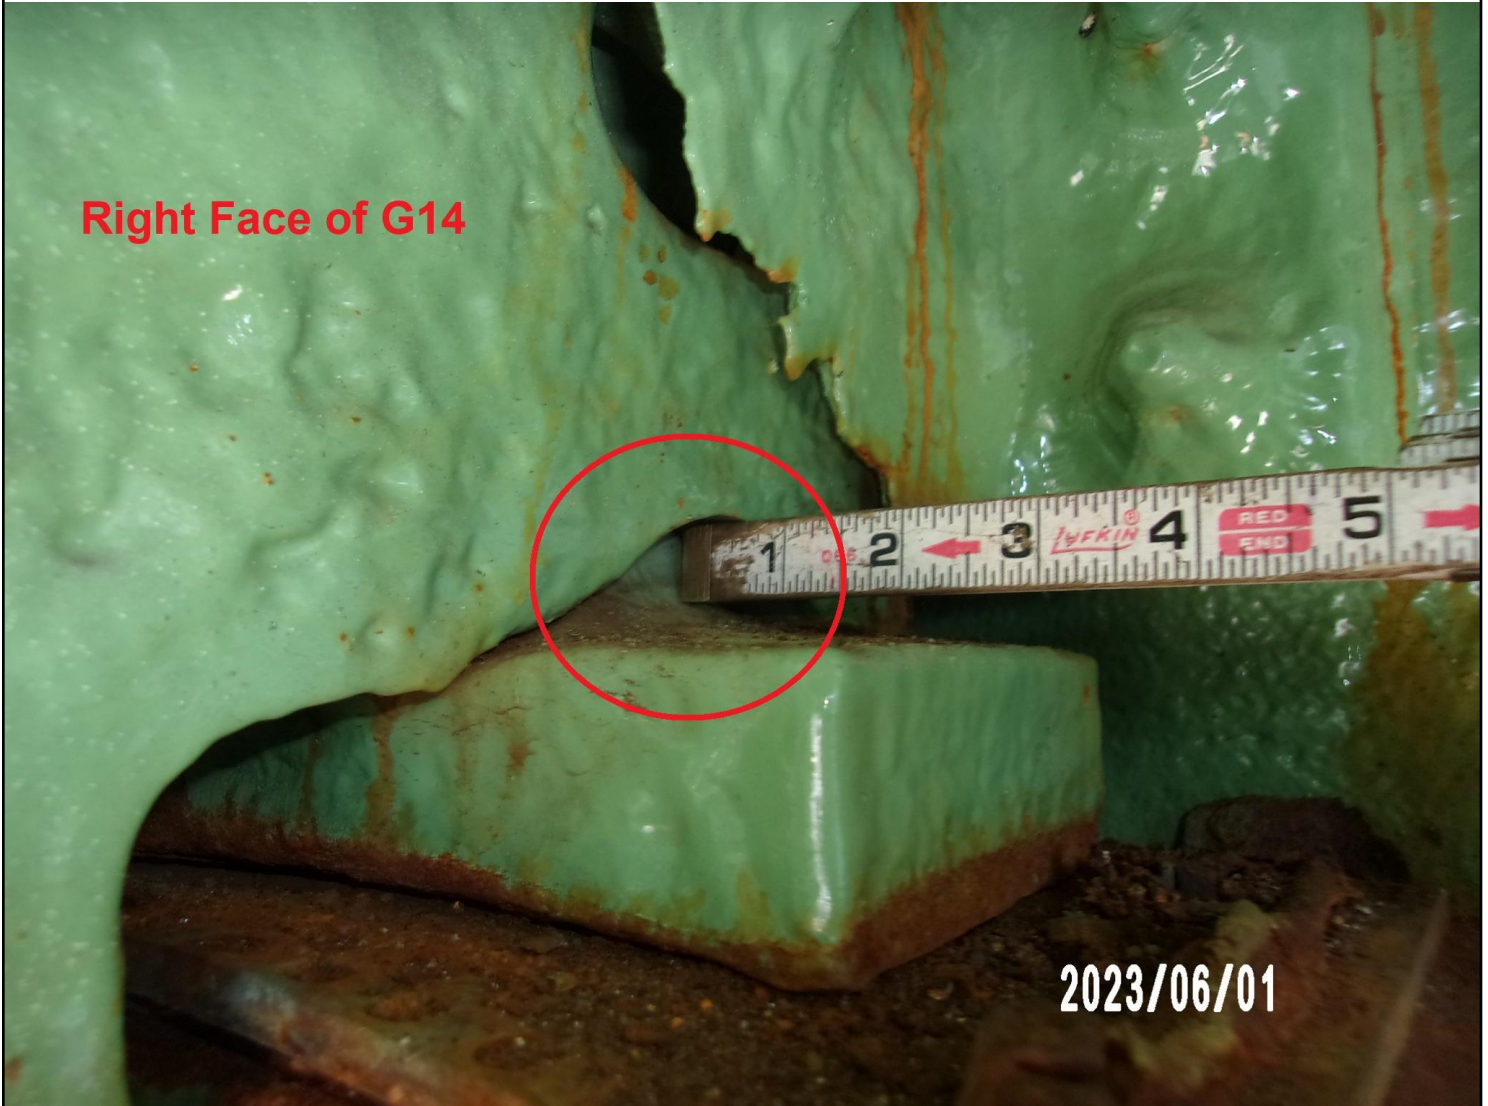
Photo Number: 5

Attachment Description: The right side of the bearing under Girder G14 on Span 164 side of Pier 164. The bearing is misaligned and no longer engaged with the girder with the bearing spindle pushed towards the left side resulting in the girder web overhanging the right side of the bearing for approximately 1/2". Looking Left.

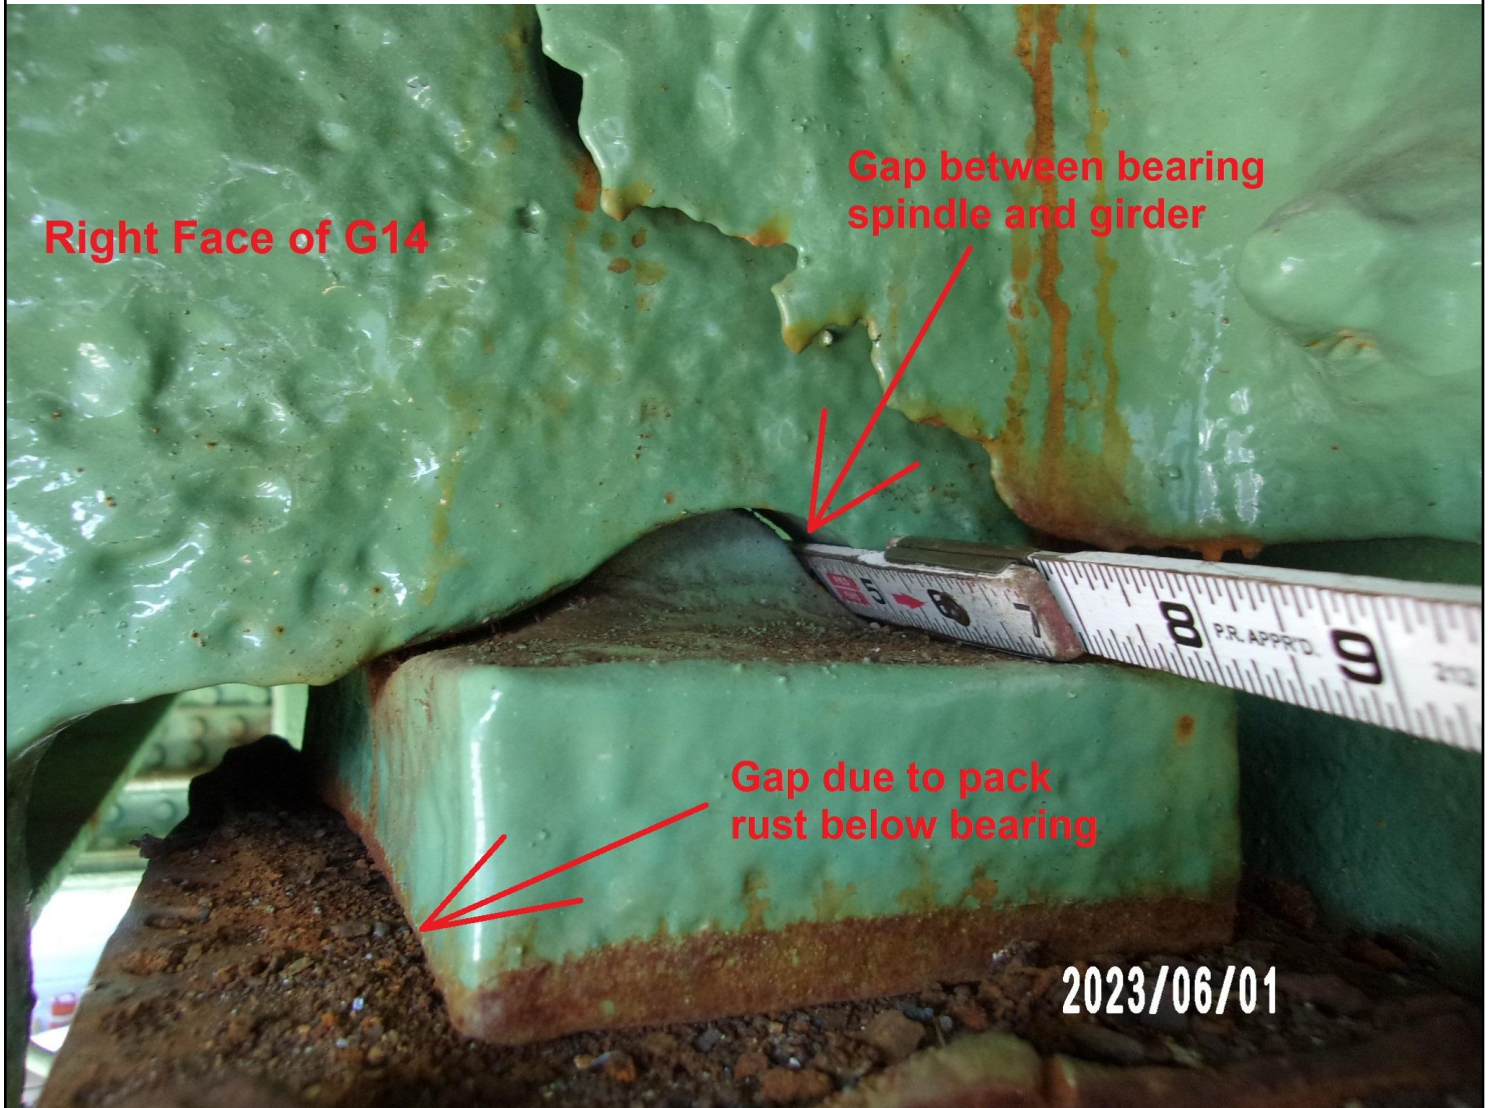
Photo Number: 6

Attachment Description: The right side of the bearing under Girder G14 on Span 164 side of Pier 164. The bearing exhibits 1/4" gap between the bearing spindle and girder web. Also, the bearing exhibits pack rust between the masonry plate and the bearing brick shaped device resulting in a 1/8" gap allowing the bearing device to move laterally upon by hand. Looking Left.

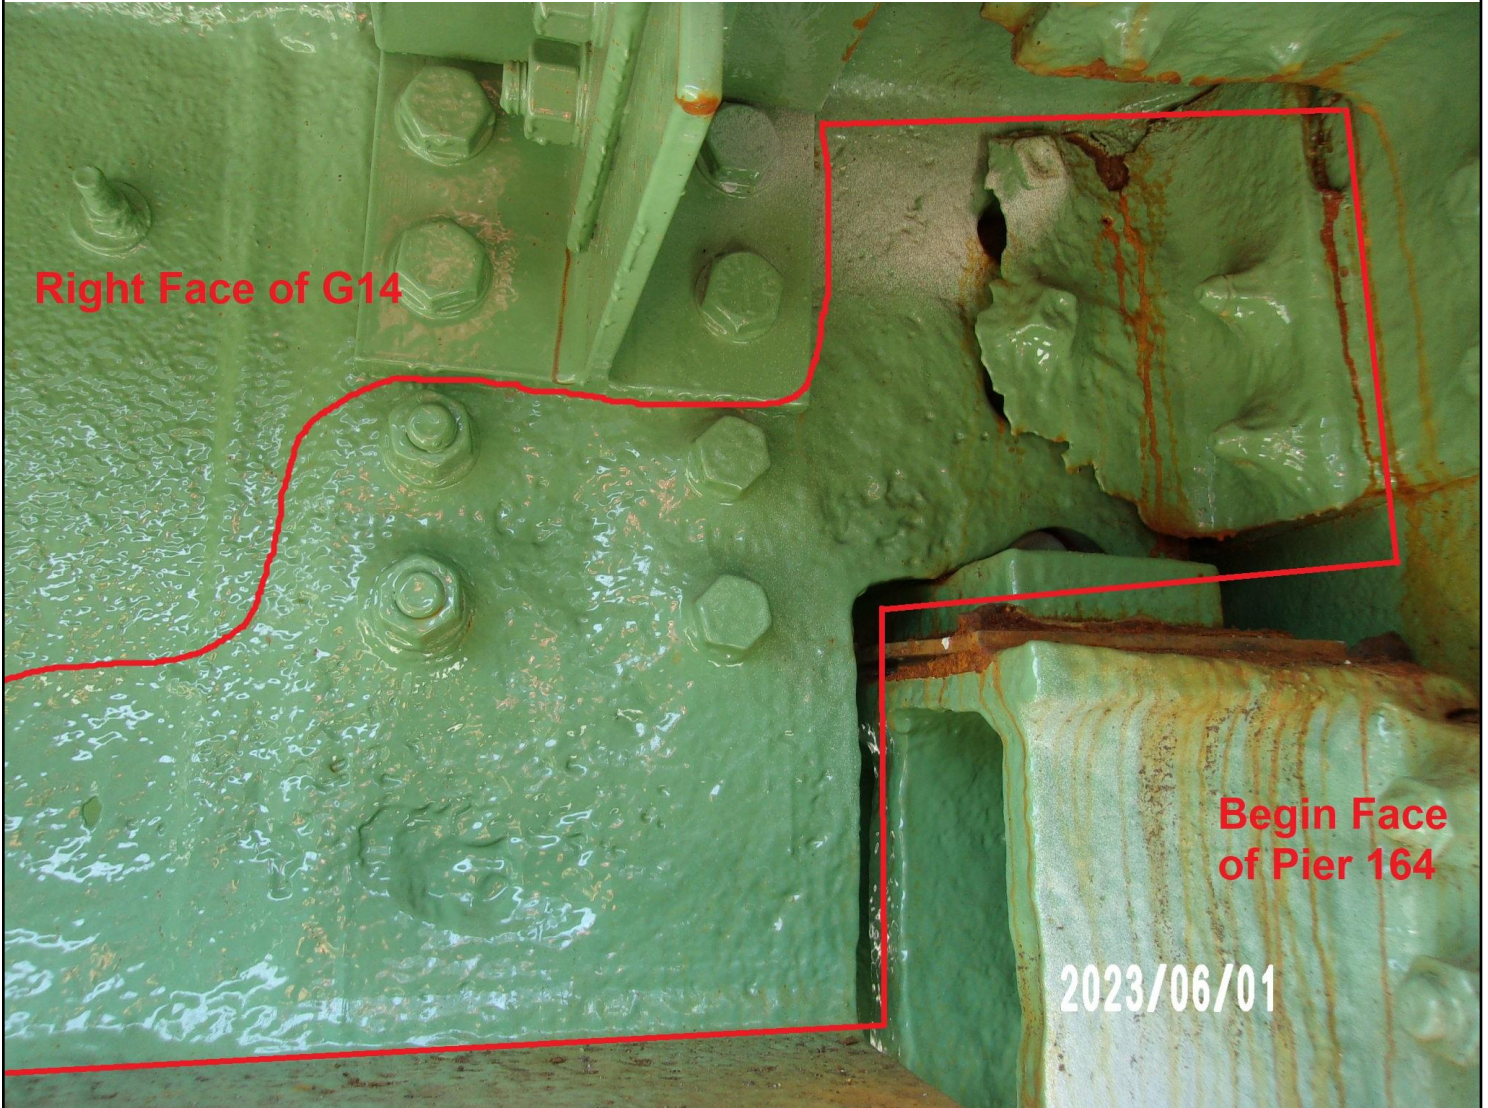
Photo Number: 7

The girder web has as-measured web thickness of approximately 2-1/2" for approximately 18-1/2" long area starting at the girder end followed by 0.667" for remaining length of girder. The girder web above the bearing exhibits 1-1/2" to 2" remaining web thickness measured (RTM) resulting in 11%-33% section loss with the overall shear web area section loss of approximately 24%. The lower web area above the bottom flange in front of the bearing (begin side of the bearing) exhibits 1.82"-1.87" RTM (as-measured web thickness of 2-1/2") and 0.125"-0.30" RTM (as-measured web thickness of 0.667") resulting in 17%-81% section loss with the overall web bearing area section loss of approximately 38%. In addition, the lower web exhibits three corrosion holes for 1/2" diameter, 2"L x 1-1/2"H, and 4-1/2"L x 2"H starting approximately 21-1/2" from the end of the girder. Also, the bottom flange of the girder exhibits up to 75% section loss over both leg for 6" wide area over 65" long. (Photos 7 and 8)

Attachment Description: The right face of Girder G14 on Span 164 side of Pier 164. The guide angle exhibits 100% section loss along the edge with up to 90% section loss in the remaining area. Also, the bolts and nuts at the guide angle exhibit 50%-75% section loss. In addition, the girder web above the bearing exhibits 11%-33% section loss with the overall shear web area section loss of 24%. Looking Left.

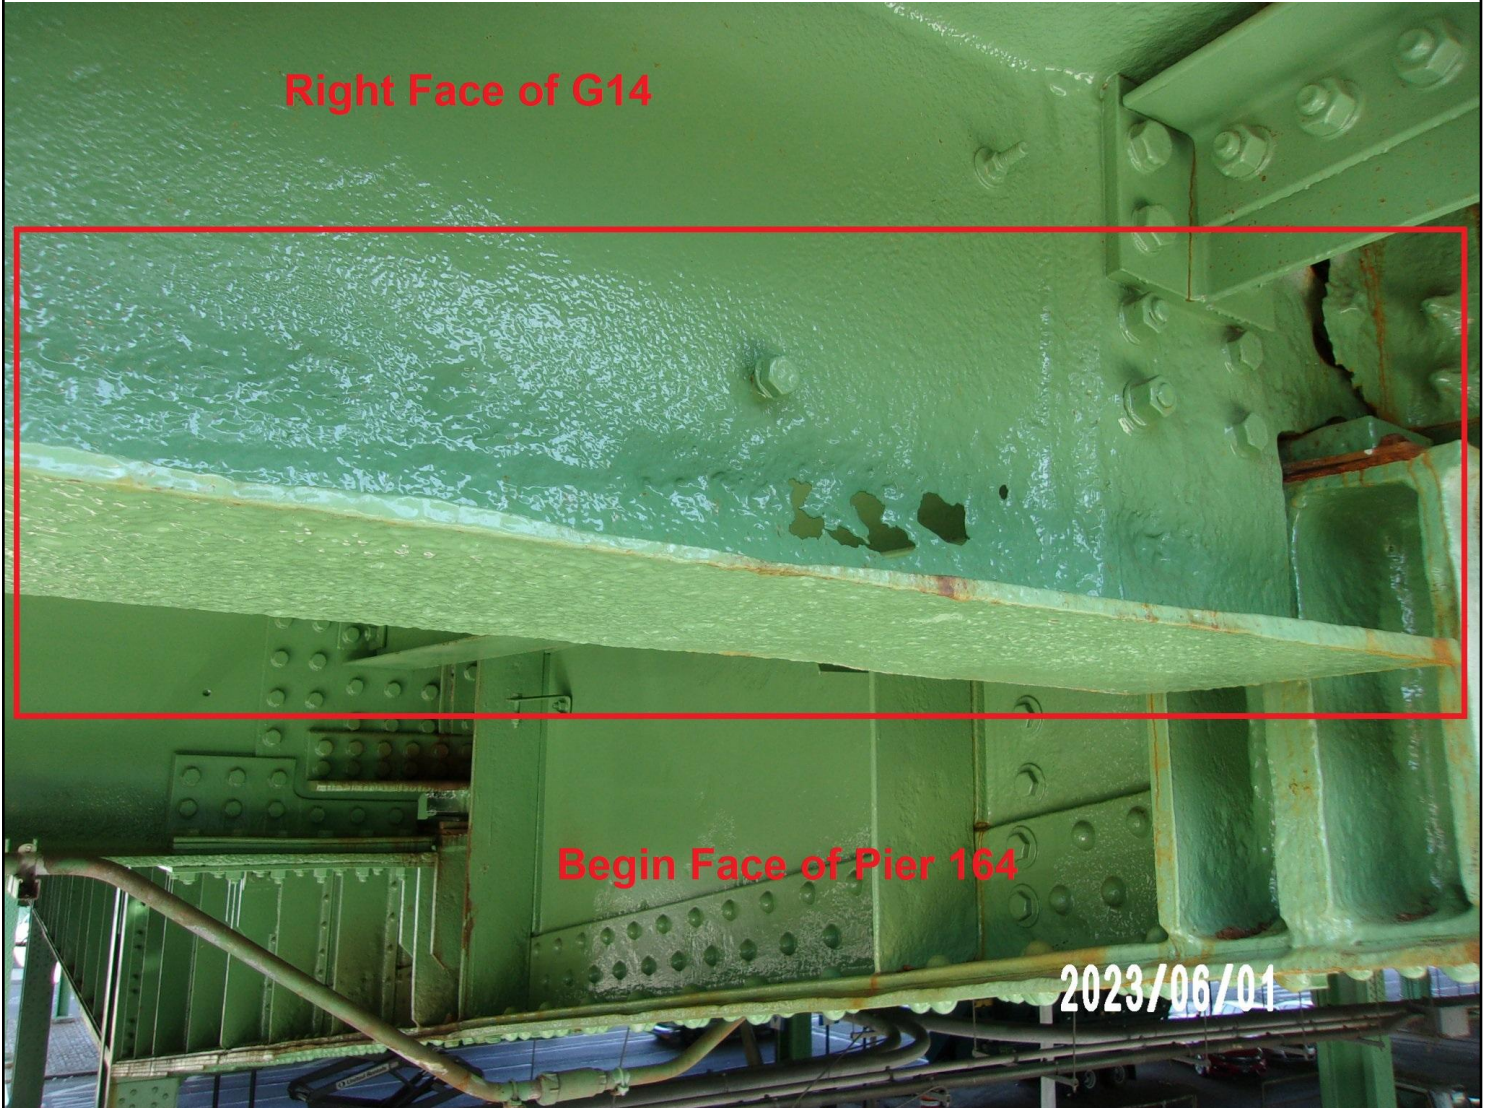
Photo Number: 8

Attachment Description: The right face of Girder G14 on Span 164 side of Pier 164. The lower web above the bottom flange exhibits 17%-81% section loss with the overall web bearing area section loss of approximately 38%. In addition, the lower web exhibits three corrosion holes for 1/2" diameter, 2"L x 1-1/2"H, and 4-1/2"L x 2"H. Also, the bottom flange exhibits up to 75% section loss. Looking End and Left.
